Project Scope: Optimizing coiled tubing life

Location: Kindersley, Sask.

String Size: 73mm (2-7/8") mono wall

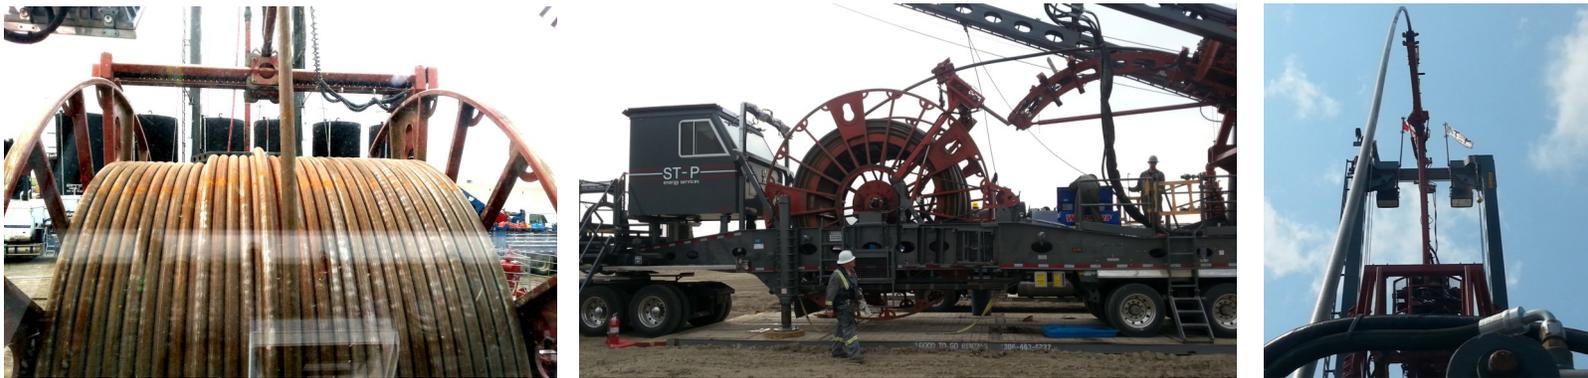
To accomplish this management strategy, CT wall thickness is measured before each job to track wear from well to well. As data is collected and processed, it creates a valuable CT profile that can be leveraged for future plans. This CT profile allowed STEP's team to pinpoint the optimal time for reversal while working with the client to meet their operational timeline. The monitoring process also provided an instantaneous snapshot of the string's status as soon as STEP's field professionals entered their data. This becomes a beneficial tool for the on-site client representative and depicts an accurate representation of the CT's real-time condition.

STEP noticed that the coiled tubing (CT) located at the core of the reel had a higher wear rate than what is encountered at the tail end. By reversing the string after 26 jobs, STEP was able to get an additional 14 jobs out of the string and take advantage of the wall thickness still present at the whip end.
